Vehicles Sent or Marked for Surplus			
Vehicle #	Department	Description	Status
6105A	Police	2011 Ford Crown Victoria	Needs Immediate Consideration
6108A	Police	2011 Ford Crown Victoria	Needs Immediate Consideration
6114A	Police	2011 Ford Crown Victoria	Needs Immediate Consideration
6119A	Police	2011 Ford Crown Victoria	Needs Immediate Consideration
6120A	Police	2011 Ford Crown Victoria	Needs Immediate Consideration
6122A	Police	2011 Ford Crown Victoria	Needs Immediate Consideration
6125A	Police	2011 Ford Crown Victoria	Needs Immediate Consideration
6126A	Police	2011 Ford Crown Victoria	Needs Immediate Consideration
6134A	Police	2011 Ford Crown Victoria	Needs Immediate Consideration
6358	Police	2013 Toyota Camry	Total Loss
6780	Police	2008 Ford Crown Victoria	Needs Immediate Consideration
6784	Police	2007 Chevrolet Impala	Needs Immediate Consideration

**City of Pembroke Pines
Fleet Services
Vehicle Replacement Analysis and Summary**

2011 Ford CROWN VICTORIA

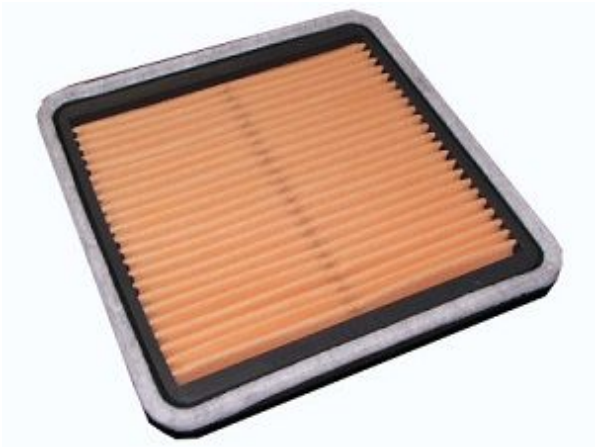
If not replaced, poor gas mileage and premature engine wear will result.

Engine Air Filter Replacement

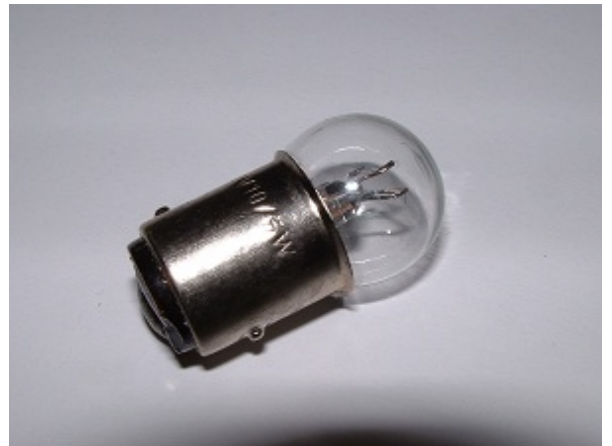
Brake Light

If not replaced, you will fail the vehicle inspection and could receive a ticket for improper equipment.

Bulb - Brake Light: brake light switch

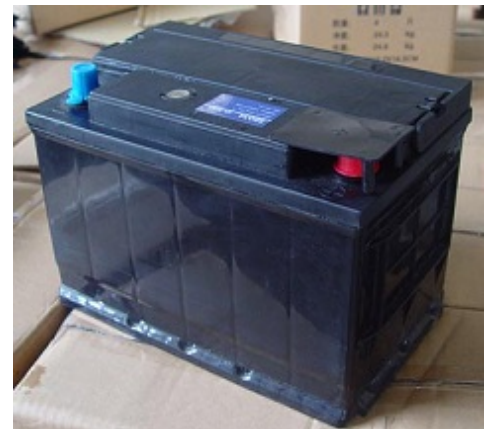
If the battery is not replaced periodically, the battery will fail. Also, a defective battery can contribute to starter failure.

Battery Replacement

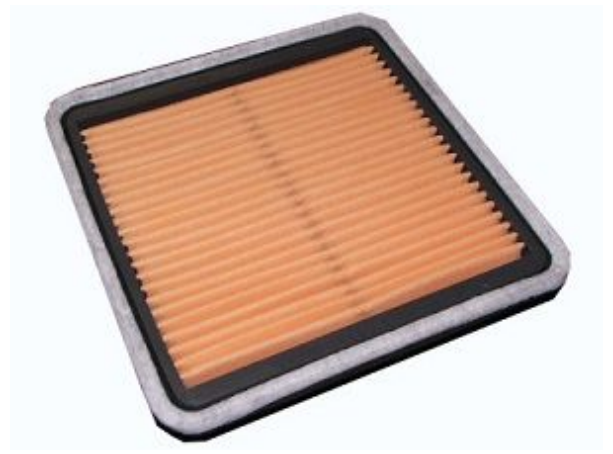
If not replaced, poor gas mileage and premature engine wear will result.

Engine Air Filter Replacement

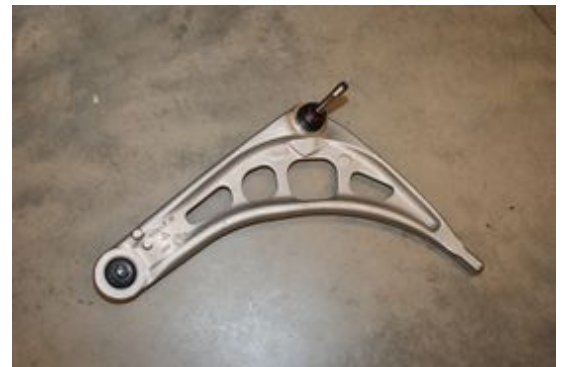
If not replaced, a bad lower control arm can cause tire cupping.

Control Arm - Lower: Both front lower control arm bushings.

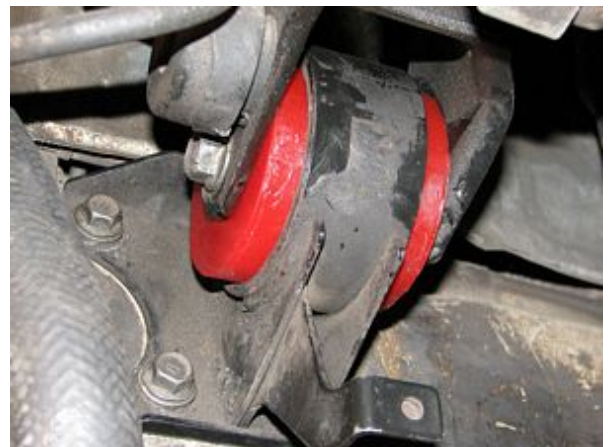
If not replaced, the motor mount gets hard and then the rubber cushion between the motor and the frame then breaks. At that point you will experience vibrations and noises magnified because

of the metal to metal contact. Worn engine mounts allow the engine to move more than normal, which can damage heater core connections.

Motor Mount: Left engine mount.

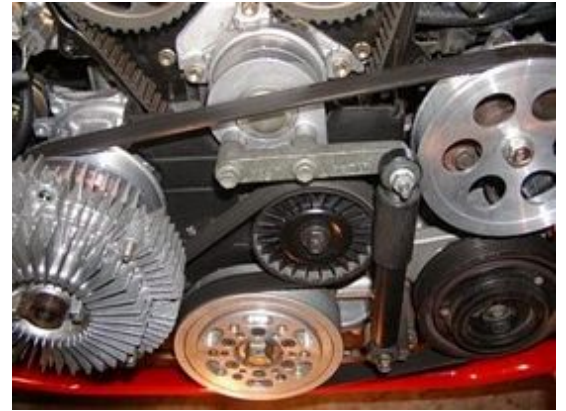
Drive Belt

With multiple belt systems, if a worn belt is not replaced and breaks, such as the alternator belt, the driver may not realize that there is a problem before the engine becomes damaged.

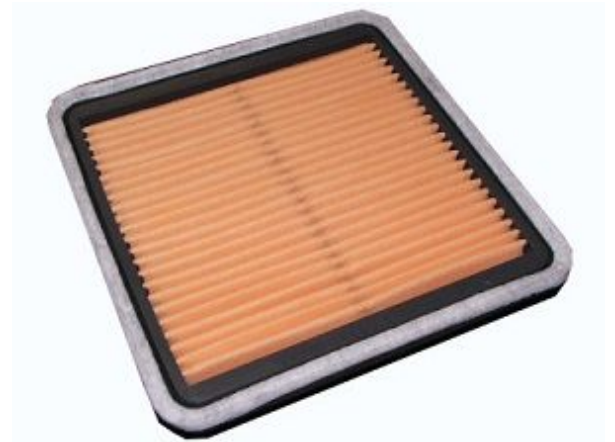
If not replaced, poor gas mileage and premature engine wear will result.

Engine Air Filter Replacement

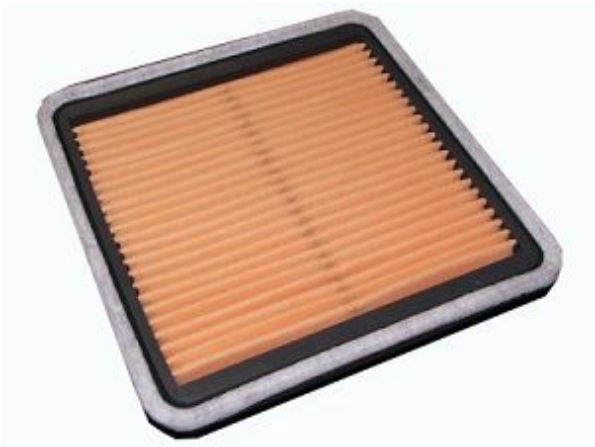
If not replaced, poor gas mileage and premature engine wear will result.

Engine Air Filter Replacement

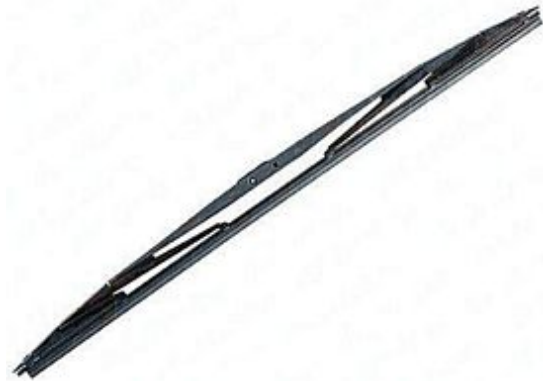
Windshield Wiper Blade

If not replaced, worn out wiper blades can cause restricted visibility and permanent damage to the windshield.

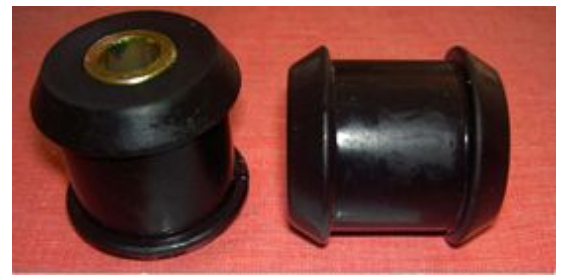
Control Arm Bushings

If not replaced, vehicle handling, cornering and overall control will be adversely affected, e.g. floating. Weak control arm bushings will flex so much during "wheel hop" that damage can occur to the drive train.

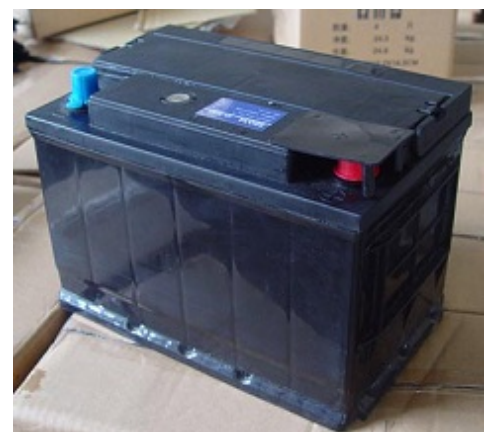
If the battery is not replaced periodically, the battery will fail. Also, a defective battery can contribute to starter failure.

Battery Replacement

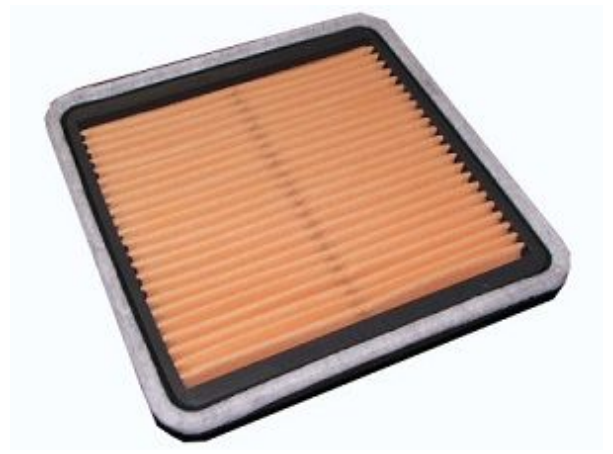
If not replaced, poor gas mileage and premature engine wear will result.

Engine Air Filter Replacement

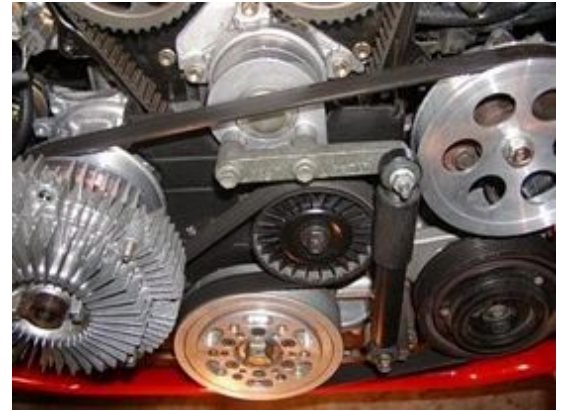
Drive Belt

With multiple belt systems, if a worn belt is not replaced and breaks, such as the alternator belt, the driver may not realize that there is a problem before the engine becomes damaged.

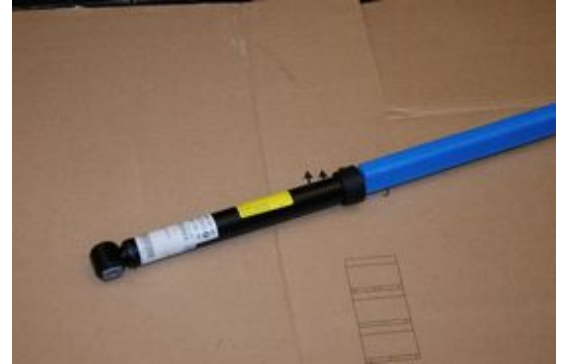
Shock Absorber

If not replaced, worn shock absorbers lose their ability to maintain tire contact with the road and provide passenger comfort.

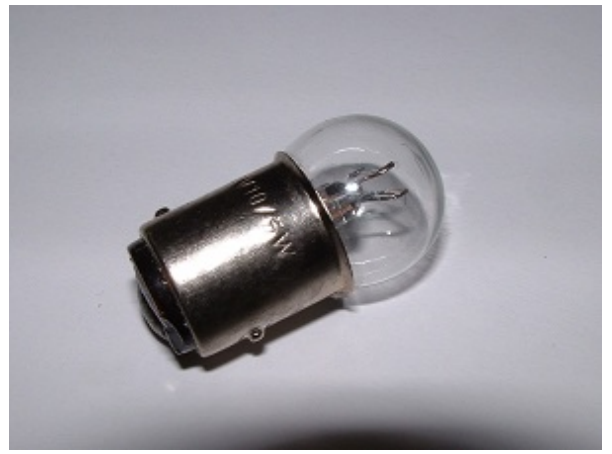
Brake Light

If not replaced, you will fail the vehicle inspection and could receive a ticket for improper equipment.

Bulb - Brake Light: brake light switch

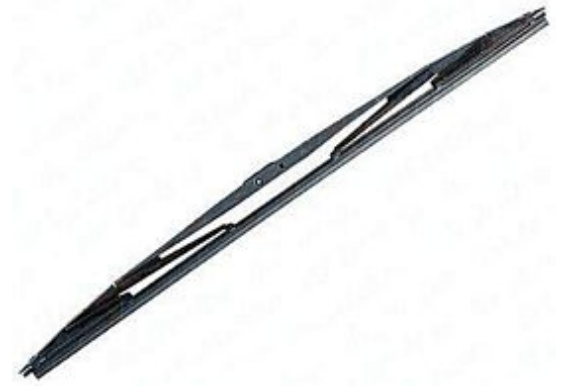
Windshield Wiper Blade

If not replaced, worn out wiper blades can cause restricted visibility and permanent damage to the windshield.

Wiper Blade Replacement

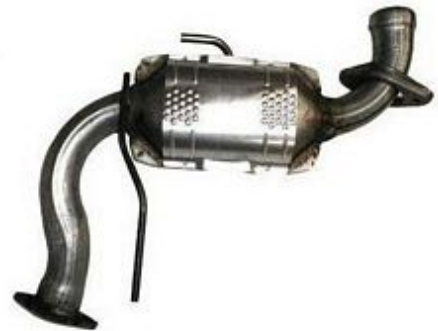
If not replaced, a failing catalytic converter will cause the vehicle to fail an emission test. It can become noisy and smell offensively. It can restrict gas flow causing the engine to run poorly or not at all.

Exhaust Catalytic Converter Replacement: Right Hand Dual Exhaust Catalytic converter + Diag.

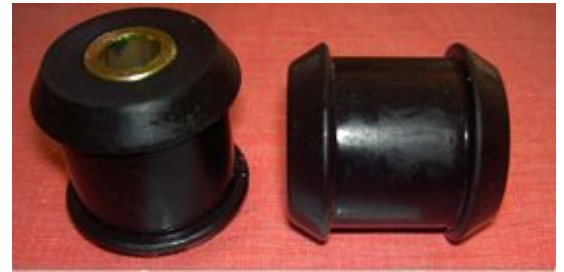
Control Arm Bushings

If not replaced, vehicle handling, cornering and overall control will be adversely affected, e.g. floating. Weak control arm bushings will flex so much during "wheel hop" that damage can occur to the drive train.

Control Arm Bushings: Left and right lower control arm BUSHINGS.

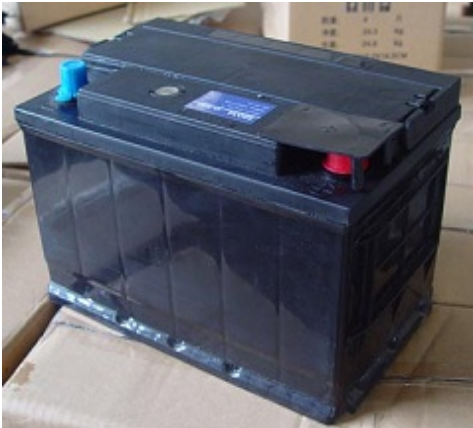
Battery

If the battery is not replaced periodically, the battery will fail. Also, a defective battery can contribute to starter failure.

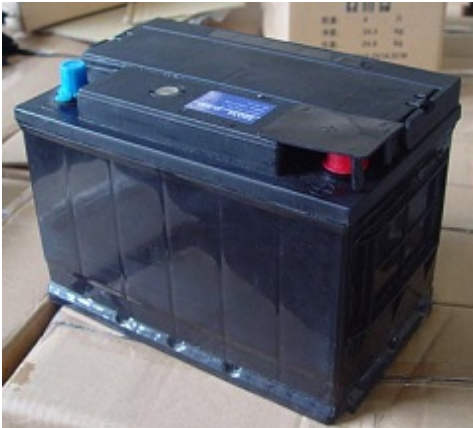
Battery

If the battery is not replaced periodically, the battery will fail. Also, a defective battery can contribute to starter failure.
