Vehicles Sent or Marked for Surplus					
Vehicle #	Vehicle # Department Description		Status			
3610	Technology Service Division	2007 FORD T150	Vehicle is 12 years old and being recommended for replacement			
5589	Recreation Department	2005 CHEVROLET MALIBU	Vehicle is 14 years old and being recommended for replacement.			
5586	Recreation Department	2004 CHEVROLET IMPALA	Vehicle is 15 years old and being recommended for replacement. This unit was used as a Fire Training vehicle - No Report Generated			
5560	Recreation Department	2001 CHEVROLET S10 BLAZER	Vehicle is 18 years old and being recommended for replacement			
6785	Police Department	2007 CHEVROLET IMPALA	Vehicle is 12 years old and being recommended for replacement			
6784	Police Department	2007 CHEVROLET IMPALA	Vehicle is 12 years old and being recommended for replacement			
6786	Police Department	2007 CHEVROLET IMPALA	Vehicle is 12 years old and being recommended for replacement

City of Pembroke Pines Fleet Services Vehicle Replacement Analysis and Summary

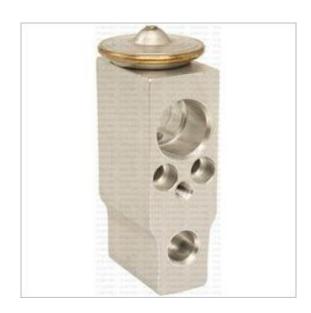
AC Evaporator Replacement

The air conditioning evaporator cools and dehumidifies air in the passenger compartment of the vehicle.

If not replaced, the A/C Evaporator will fail, causing the air conditioning system to not function properly.

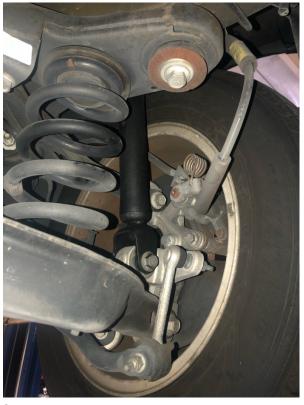
Shock Absorber

If not replaced, worn shock abosorbers loose their ability to maintain tire contact with the road and provide passenger comfort.

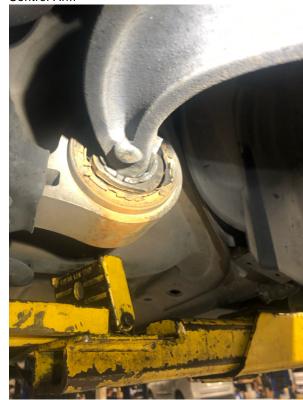
Control Arm

The lower control arm is part of the vehicle's suspension system. It attaches the front suspension

to the chassis, stabilizing the suspension's fore and aft movement. A control arm can also be referred to as a "wishbone" or an "A-arm."
