Vehicles Sent or Marked for Surplus							
Vehicle #							
3332	Fire Department	2001 CHEVROLET S10 PICKUP	Vehicle is 20 years old and being recommended for replacement				
7393	Fire Department	2007 FORD FOCUS	Vehicle is 14 years old and being recommended for replacement				
3322	Fire Department	2006 CHEVROLET MALIBU	Vehicle is 15 years old and being recommended for replacement				
7795	Fire Department	2007 CHEVROLET IMPALA	Vehicle is 14 years old and being recommended for replacement				
3401	Planning Department	2006 CHEVROLET MALIBU	Vehicle is 15 years old and being recommended for replacement				
6662	Police Department	2016 CHEVROLET TAHOE	Vehicle is a total loss				
61704	Police Department	2017 CHEVROLET TAHOE	Vehicle is a total loss				
61719	Police Department	2017 CHEVROLET TAHOE	Vehicle is a total loss				
6446	Police Department	2015 CHEVROLET TAHOE	Vehicle is a total loss				
6240	Police Department	2012 TOYOTA CAMRY	Vehicle is a total loss

City of Pembroke Pines Fleet Services Vehicle Replacement Analysis and Summary

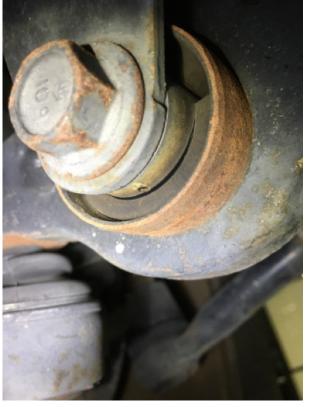
Control Arm - Lower: Both front lower control arms.

If not replaced, a bad lower control arm can cause tire cupping.

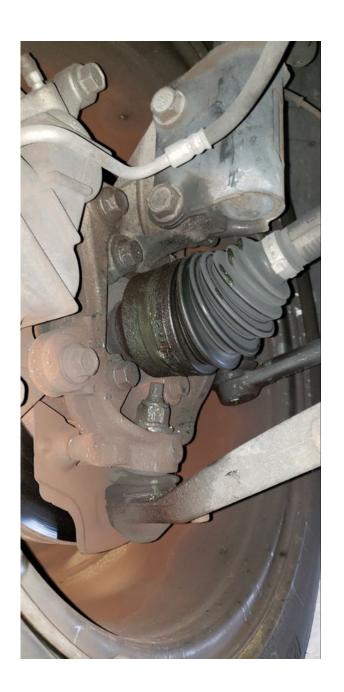
Brake Job - Front (Replace Pads and Rotors): rotors heat spotted

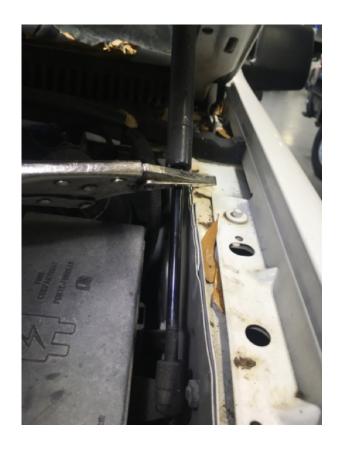
[Other]: Hood molding (See picture).
