**City of Pembroke Pines
Fleet Services
Vehicle Replacement Analysis and Summary**

Vehicle #: 6143
Division/Unit: Police
Year: 2011
Make/Model: Chevrolet Tahoe
Mileage: 42,464

Automobile Status Report

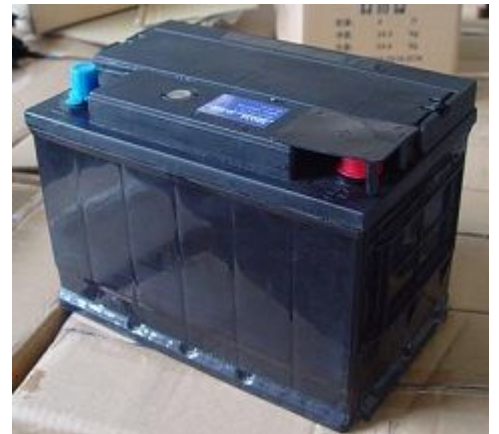
Battery Replacement

If the battery is not replaced periodically, the battery will fail. Also, a defective battery can contribute to starter failure.

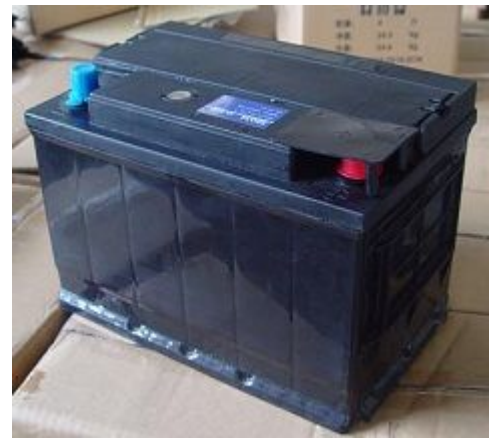
Battery Replacement: leaking acid

If the battery is not replaced periodically, the battery will fail. Also, a defective battery can contribute to starter failure.

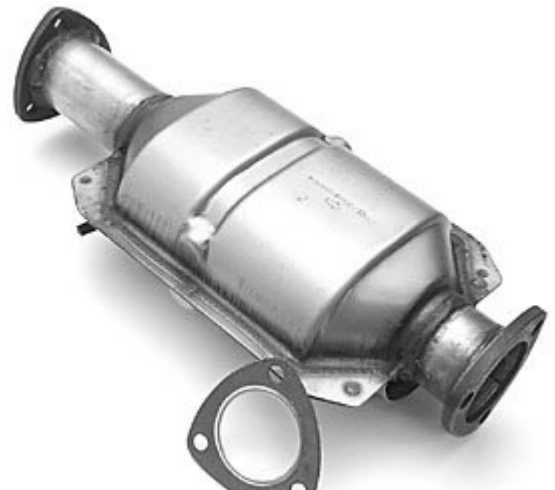
Catalytic Converter and Gaskets: Catalytic converter Bank 2 (repl.) + Diag.

A catalytic converter may become clogged, poisoned, or physically damaged. When the catalytic converter becomes clogged you may actually feel the decrease in performance and notice a decrease in fuel economy. A clogged catalytic converter traps exhaust gas in front of the catalyst. This trapped exhaust gas creates back-pressure which prevents the your engine from breathing properly. The increased back-pressure may also cause the engine to quit after a few minutes of driving or make the engine feel like it is starving for fuel. Sometimes you may actually hear a whistling sound when the throttle is applied indicating a restricted exhaust flow or catalytic converter problem.

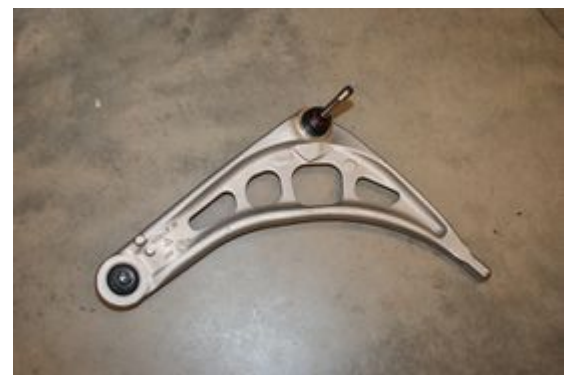
Control Arm - Lower: Left and right front lower control arms (complete).

If not replaced, a bad lower control arm can cause tire cupping.

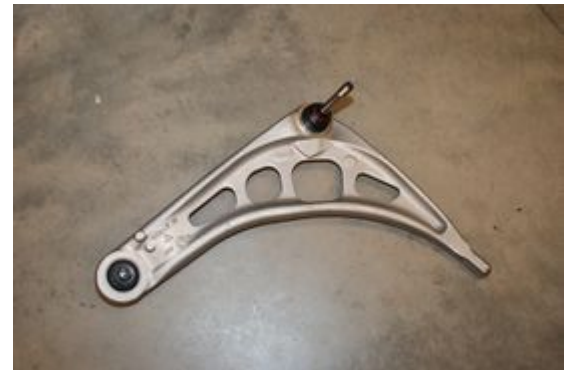
Control Arm - Lower: bushings broken on both sides

If not replaced, a bad lower control arm can cause tire cupping.

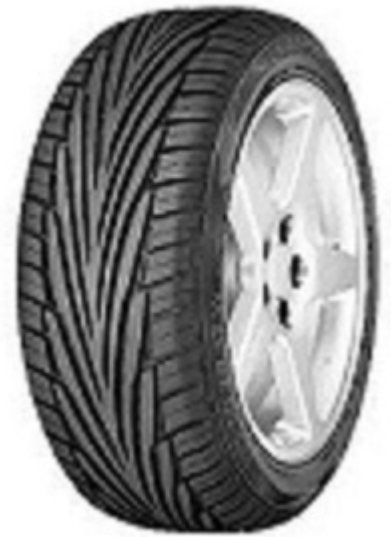
Tires - 2: Low tread

If snow-covered roads are a concern, you should consider replacing your tires when they reach approximately 6/32" of remaining tread depth to maintain good mobility. Because tread depth is such an important element for snow traction, winter tires usually start with noticeably deeper tread depths than typical All-Season or summer tires. Some winter tires even have a second series of "wear bars" molded in their tread pattern indicating approximately 6/32" remaining tread depth to warn you when your tires no longer meet the desired tread depth.

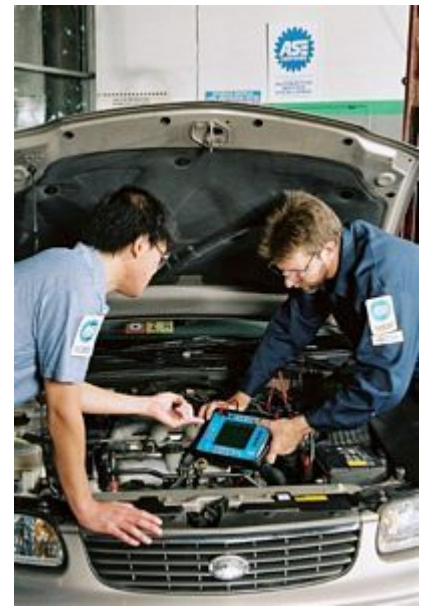
Diagnostic: Clunking noise while turning

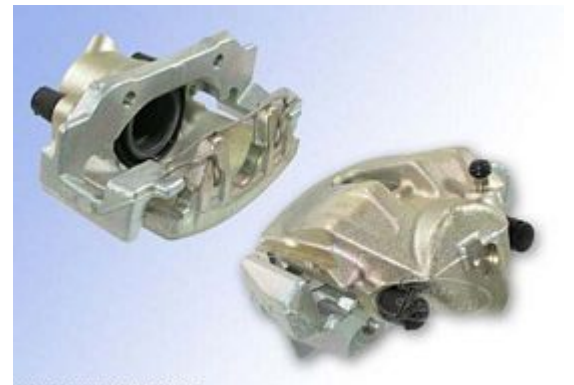
Brake Caliper Replacement - Rear: Both rear brake calipers (repl.) + Bleed the system + Diag.

If not replaced, the brake caliper will fail causing a dangerous condition where either the vehicle will not stop or will pull severely to one side when it
