Vehicles Sent or Marked for Surplus					
Vehicle #	Vehicle # Department Description		Status			
3610	Technology Service Division	2007 FORD T150	Vehicle is 12 years old and being recommended for replacement			
5589	Recreation Department	2005 CHEVROLET MALIBU	Vehicle is 14 years old and being recommended for replacement.			
5586	Recreation Department	2004 CHEVROLET IMPALA	Vehicle is 15 years old and being recommended for replacement. This unit was used as a Fire Training vehicle - No Report Generated			
5560	Recreation Department	2001 CHEVROLET S10 BLAZER	Vehicle is 18 years old and being recommended for replacement			
6785	Police Department	2007 CHEVROLET IMPALA	Vehicle is 12 years old and being recommended for replacement			
6784	Police Department	2007 CHEVROLET IMPALA	Vehicle is 12 years old and being recommended for replacement			
6786	Police Department	2007 CHEVROLET IMPALA	Vehicle is 12 years old and being recommended for replacement

City of Pembroke Pines Fleet Services Vehicle Replacement Analysis and Summary

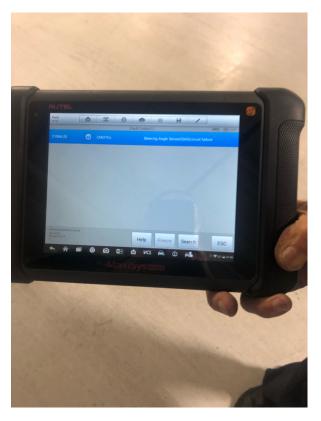
If damaged, the steering angle sensor will not be able to send the proper readings to the ABS system causing a major safety issue for the driver and their passengers.
