Vehicles Sent or Marked for Surplus							
Vehicle #							
3332	Fire Department	2001 CHEVROLET S10 PICKUP	Vehicle is 20 years old and being recommended for replacement				
7393	Fire Department	2007 FORD FOCUS	Vehicle is 14 years old and being recommended for replacement				
3322	Fire Department	2006 CHEVROLET MALIBU	Vehicle is 15 years old and being recommended for replacement				
7795	Fire Department	2007 CHEVROLET IMPALA	Vehicle is 14 years old and being recommended for replacement				
3401	Planning Department	2006 CHEVROLET MALIBU	Vehicle is 15 years old and being recommended for replacement				
6662	Police Department	2016 CHEVROLET TAHOE	Vehicle is a total loss				
61704	Police Department	2017 CHEVROLET TAHOE	Vehicle is a total loss				
61719	Police Department	2017 CHEVROLET TAHOE	Vehicle is a total loss				
6446	Police Department	2015 CHEVROLET TAHOE	Vehicle is a total loss				
6240	Police Department	2012 TOYOTA CAMRY	Vehicle is a total loss

City of Pembroke Pines Fleet Services Vehicle Replacement Analysis and Summary

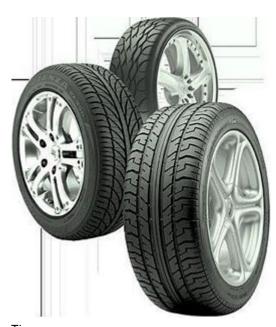
Tires

According to most states' laws, tires are legally worn

out when they have worn down to 2/32" of remaining tread depth. As a tire wears it's important to realize that the tire's ability to perform in rain and snow will be reduced. With 2/32" of remaining tread depth, resistance to hydroplaning in the rain at highway speeds has been significantly reduced, and traction in snow has been virtually eliminated. If rain and wet roads are a concern, you should consider replacing your tires when they reach approximately 4/32" of remaining tread depth.

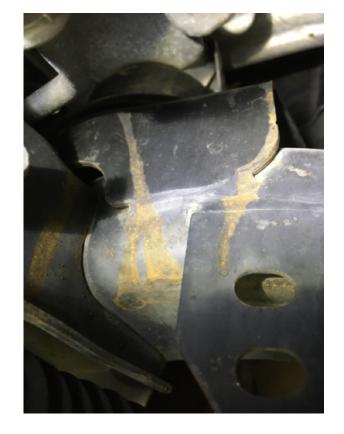
If not replaced, the motor mount gets hard and then the rubber cushion between the motor and the frame then breaks. At that point you will experience vibrations and noises magnified because of the metal to metal contact. Worn engine mounts allow the engine to move more than normal, which can damage heater core connections.

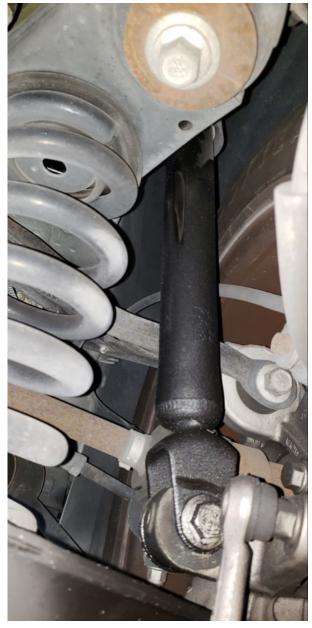
Struts

If not replaced, worn out rear struts not only affect the ride comfort and control but also affect the braking effectiveness. To continually achieve the ride comfort that you want, ensure that your struts are kept in good condition at all times. Securing immediate replacement of worn out rear struts is vital to ensuring their reliable service.

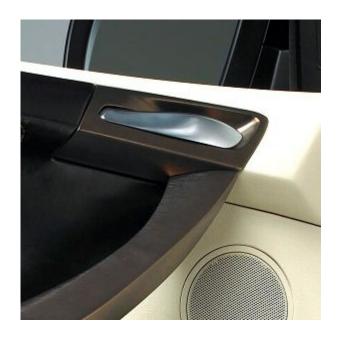
Trim can crack and even break off. Damaged trim often looks unappealing and can even create sharp surfaces.

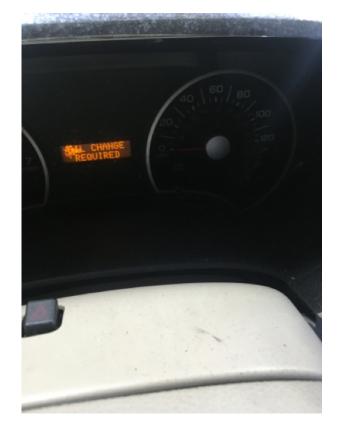
If not changed, the result will be engine overheating and engine damage.

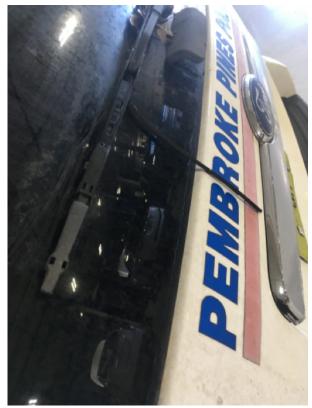
Wiper Blade Replacement

The rear windshield wiper will need to be replaced occasionally. When you notice the wiper streaking on the glass or becoming worn, remove it immediately and have it properly replaced.
