**City of Pembroke Pines
Fleet Services
Vehicle Replacement Analysis and Summary**

Vehicle #: 6143
Division/Unit: Police
Year: 2011
Make/Model: Chevrolet Tahoe
Mileage: 42,464

Automobile Status Report

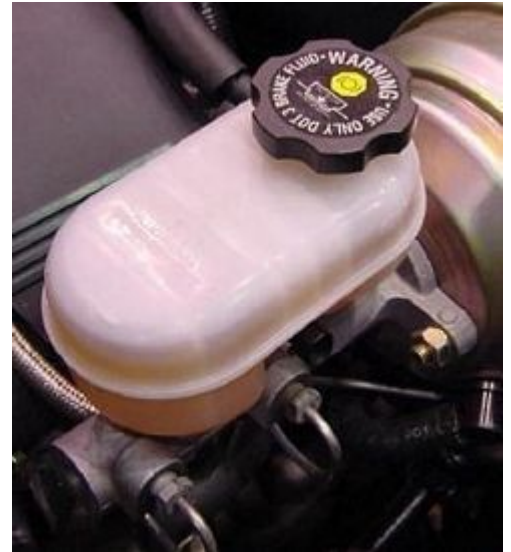
Brake Flush

If not maintained, the contaminated fluid will deteriorate the brake system resulting in unsafe brakes.

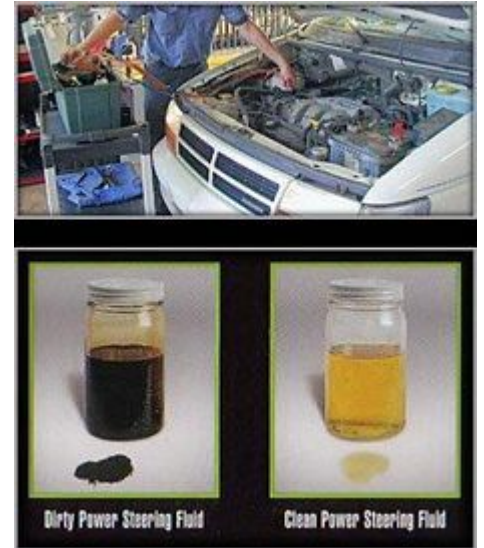
Power Steering Flush

If not replaced/flushed, your car's power steering pump may suffer from a serious mechanical problem.

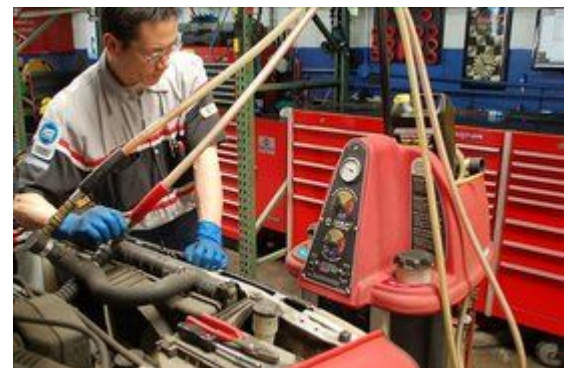
Cooling System

If not performed, the cooling system will not perform efficiently and the engine will eventually overheat causing serious engine damage.

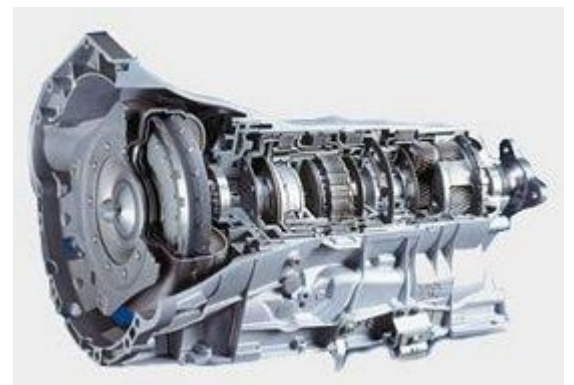
Transmission

If not done on a regular basis, automatic transmissions will become dirty and ineffective, and eventually cause the transmission to shift roughly.

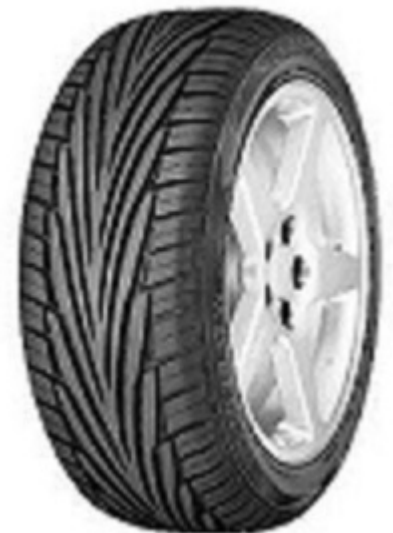
Tires

According to most states' laws, tires are legally worn out when they have worn down to 2/32" of remaining tread depth. As a tire wears it's important to realize that the tire's ability to perform in rain and snow will be reduced. With 2/32" of

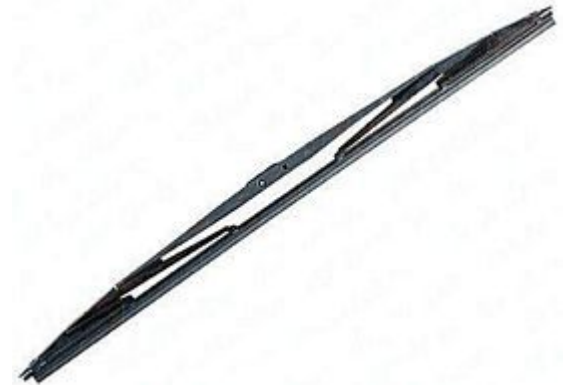
Windshield Wiper Blade

If not replaced, worn out wiper blades can cause restricted visibility and permanent damage to the windshield.

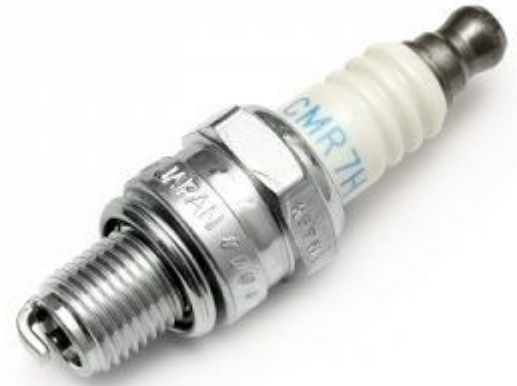
Spark Plugs

If not replaced, worn spark plugs can cause poor fuel economy, poor drivability, difficulty starting the engine, and high pollution emissions.

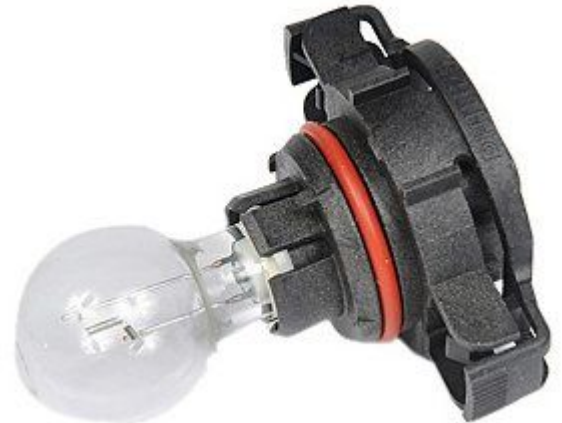
Headlamp Replacement

Bulb - Headlight (Bulb Only): Both headlight bulbs (repl.) + Diag.

If not repaired, the headlight will not function. In many states, this is a violation of the law and the automobile will not be able to pass safety inspection. This also poses a serious safety threat when operating the vehicle at night, in precipitation or in a low light settings. If a headlamp bulb is not operable, then visibility will be impaired in these conditions.

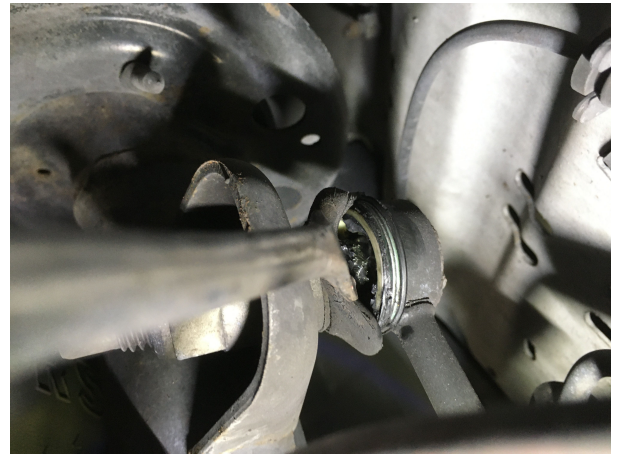
If the Stabilizer Bar Links are found to be damaged or broken the sway bars effectiveness is reduced or eliminated, resulting in a "loose" feeling in the front end of the vehicle. Potential problems include abnormal tire wear and extra stress to various other suspension components.

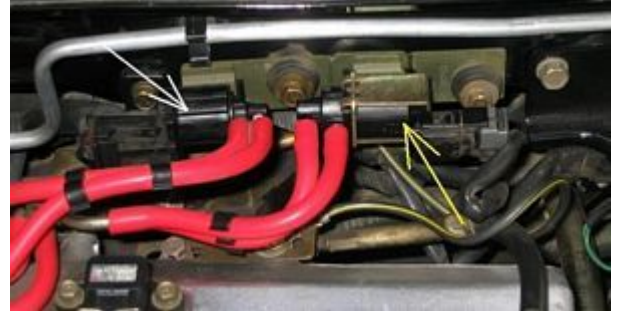
If not repaired, a faulty purge control solenoid can keep the engine's purge valve from operating at optimal performance or operating at all. An inoperable purge valve disrupts proper air flow and air/fuel mixture of the engine which can prevent the engine from running altogether.

Canister Purge Solenoid: Evaporative emission canister purge solenoid (repl.) + Diag.

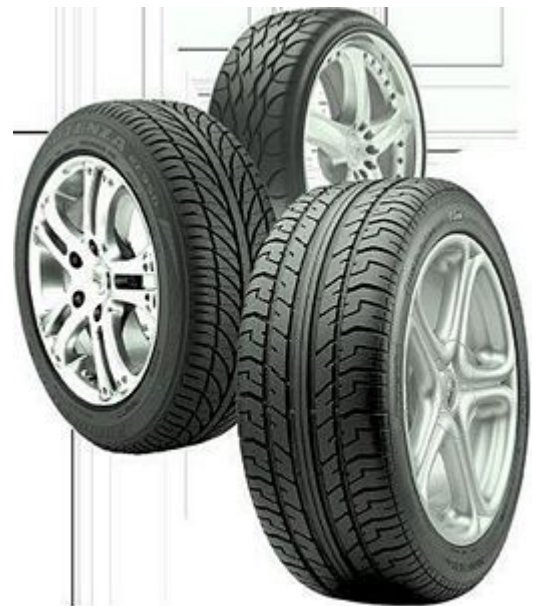
Tires

According to most states' laws, tires are legally worn out when they have worn down to 2/32" of remaining tread depth. As a tire wears it's important to realize that the tire's ability to perform in rain and snow will be reduced. With 2/32" of remaining tread depth, resistance to hydroplaning in the rain at highway speeds has been significantly reduced, and traction in snow has been virtually eliminated. If rain and wet roads are a concern, you should consider replacing your tires when they reach approximately 4/32" of remaining tread depth.

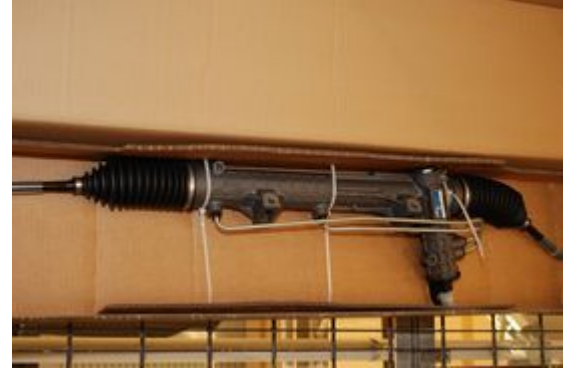
Steering Rack

If not replaced, a failing steering rack may clunk when turning or when going over bumps while driving. A failing steering rack will also cause difficulty in steering.

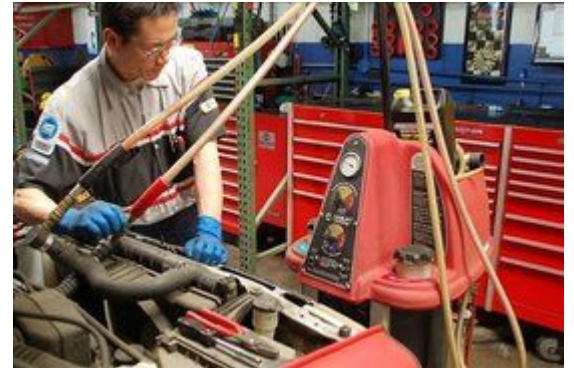
Cooling System

If not performed, the cooling system will not perform efficiently and the engine will eventually overheat causing serious engine damage.

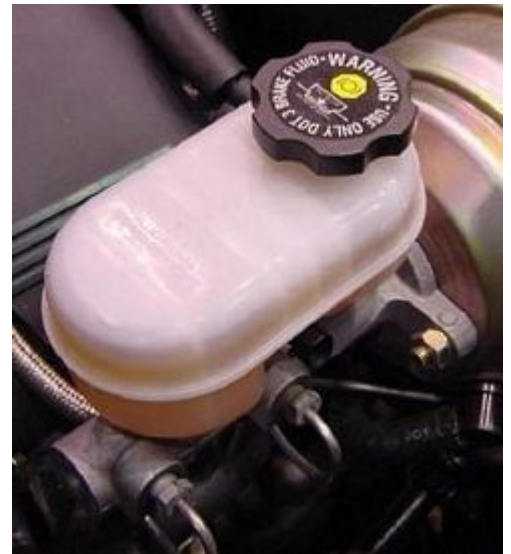
Brake Flush

Brake Fluid Service: based on mileage and fluid condition recommend brake fluid to be flushed

If not maintained, the contaminated fluid will deteriorate the brake system resulting in unsafe brakes.

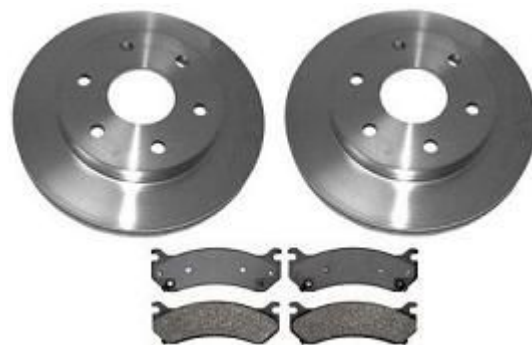
Brake pads must be replaced before the friction material is worn away completely. When replacing the brake pads it is best to replace the rotors as well. This will allow the braking system to work at its highest level of performance, and will also allow the new pads to have the longest life possible.

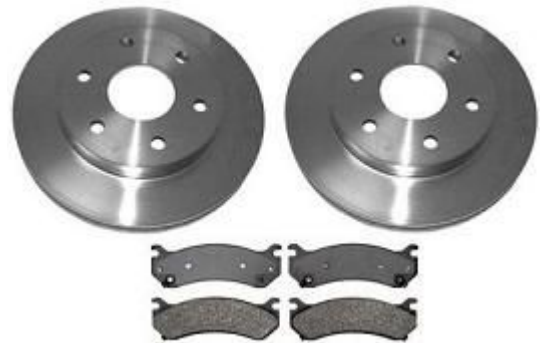
Pads&Rotors

Brake Job - Front (Replace Pads and Rotors)

Brake pads must be replaced before the friction material is worn away completely. When replacing the brake pads it is best to replace the rotors as well. This will allow the braking system to work at its highest level of performance, and will also allow the new pads to have the longest life possible.

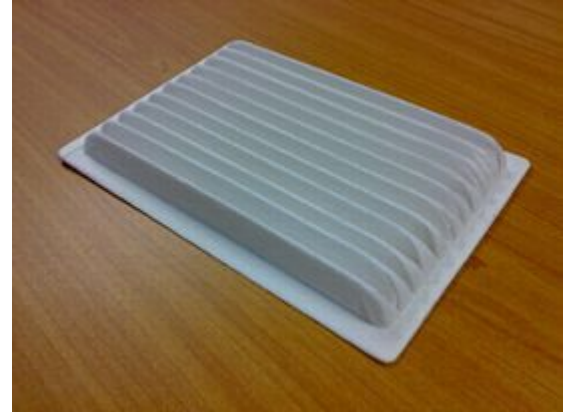
Cabin Air Filter

If not replaced, the air conditioning system will develop an odd odor. The air conditioning filter, also known as the cabin filter, removes dust and pollen from entering the car cabin.

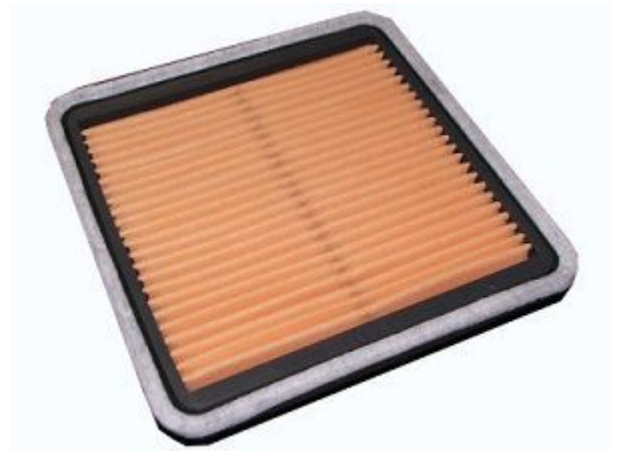
If not replaced, poor gas mileage and premature engine wear will result.

Engine Air Filter Replacement

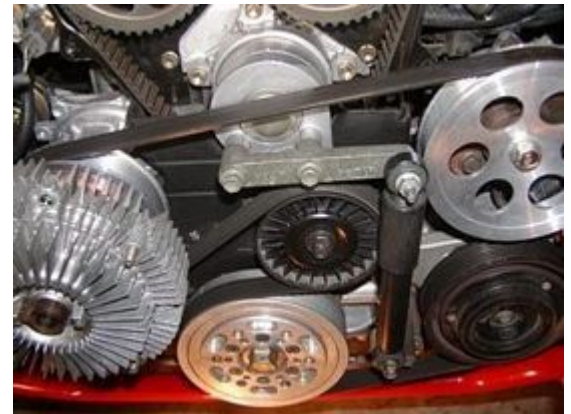
Drive Belt

With multiple belt systems, if a worn belt is not replaced and breaks, such as the alternator belt, the driver may not realize that there is a problem before the engine becomes damaged.

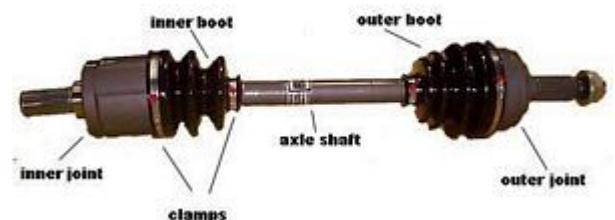
Axle Replace - Front: Passenger side axle leaking

If not repaired, the weight of the vehicle will have no support. Accelerating and braking functions will be impaired or not function at all.

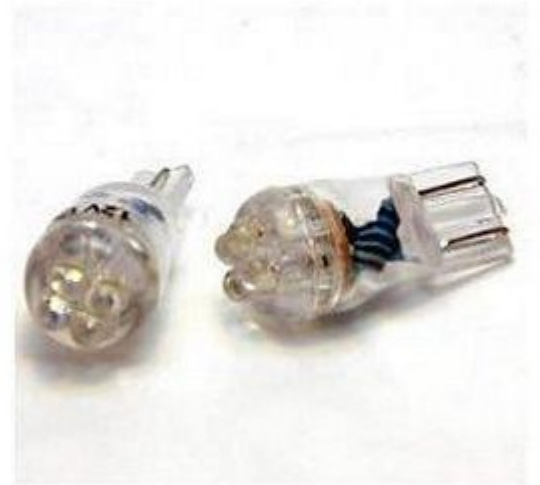
License Plate Light

If not replaced, you will fail the vehicle inspection and could receive a ticket for improper equipment.

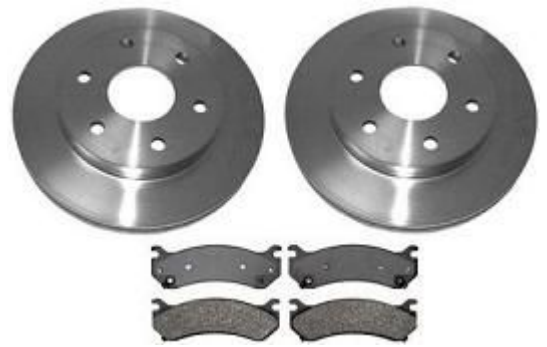
Brake Job - Rear (Replace Pads and Rotors)

Brake pads must be replaced before the friction material is worn away completely. When replacing the brake pads it is best to replace the rotors as well. This will allow the braking system to work at its highest level of performance, and will also allow the new pads to have the longest life possible.

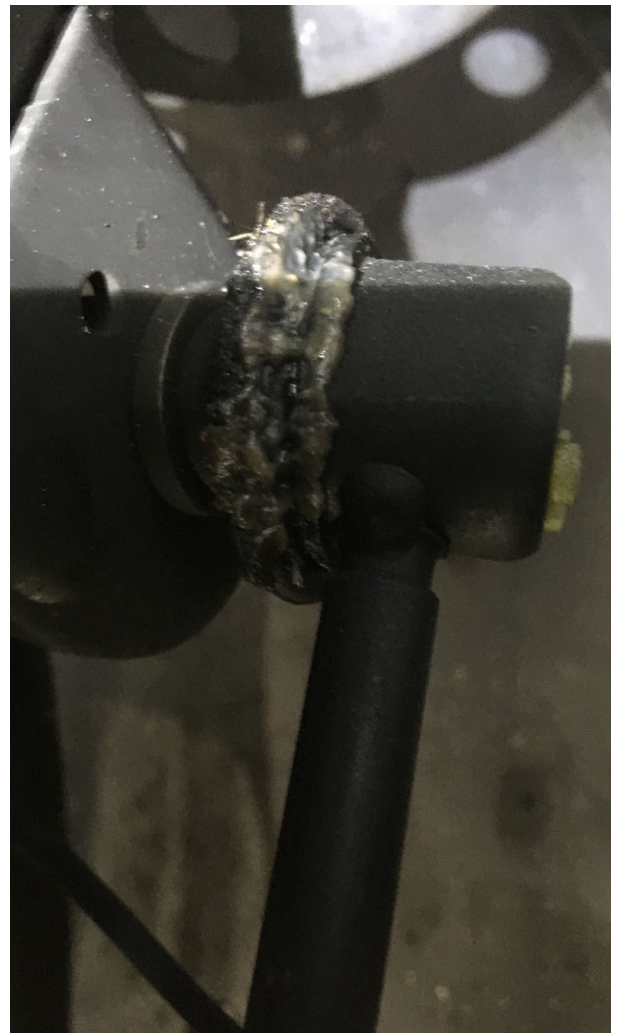
If the Stabilizer Bar Links are found to be damaged or broken the sway bars effectiveness is reduced or eliminated, resulting in a "loose" feeling in the front end of the vehicle. Potential problems include abnormal tire wear and extra stress to various other suspension components.

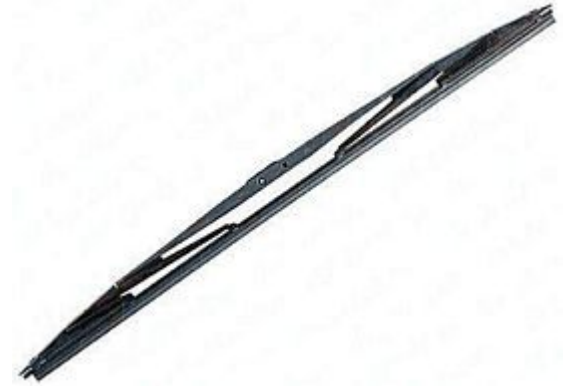
Windshield Wiper Blade

If not replaced, worn out wiper blades can cause restricted visibility and permanent damage to the windshield.

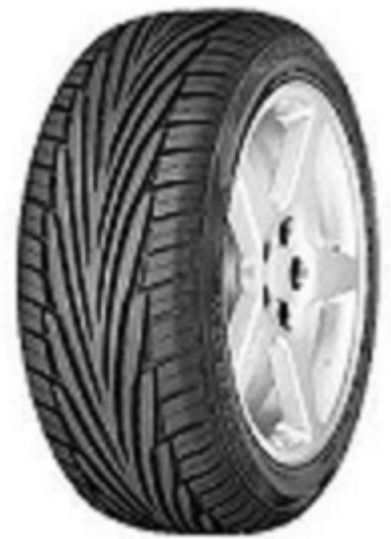
Tires

According to most states' laws, tires are legally worn out when they have worn down to 2/32" of remaining tread depth. As a tire wears it's important to realize that the tire's ability to perform in rain and snow will be reduced. With 2/32" of remaining tread depth, resistance to hydroplaning in the rain at highway speeds has been significantly reduced, and traction in snow has been virtually eliminated. If rain and wet roads are a concern, you should consider replacing your tires when they reach approximately 4/32" of remaining tread depth.
